FIRE CAUSE AND ORIGIN REPORT
Fire and Explosion at Building E3081
Edgewood Area, Aberdeen Proving Ground, Maryland

EXECUTIVE SUMMARY

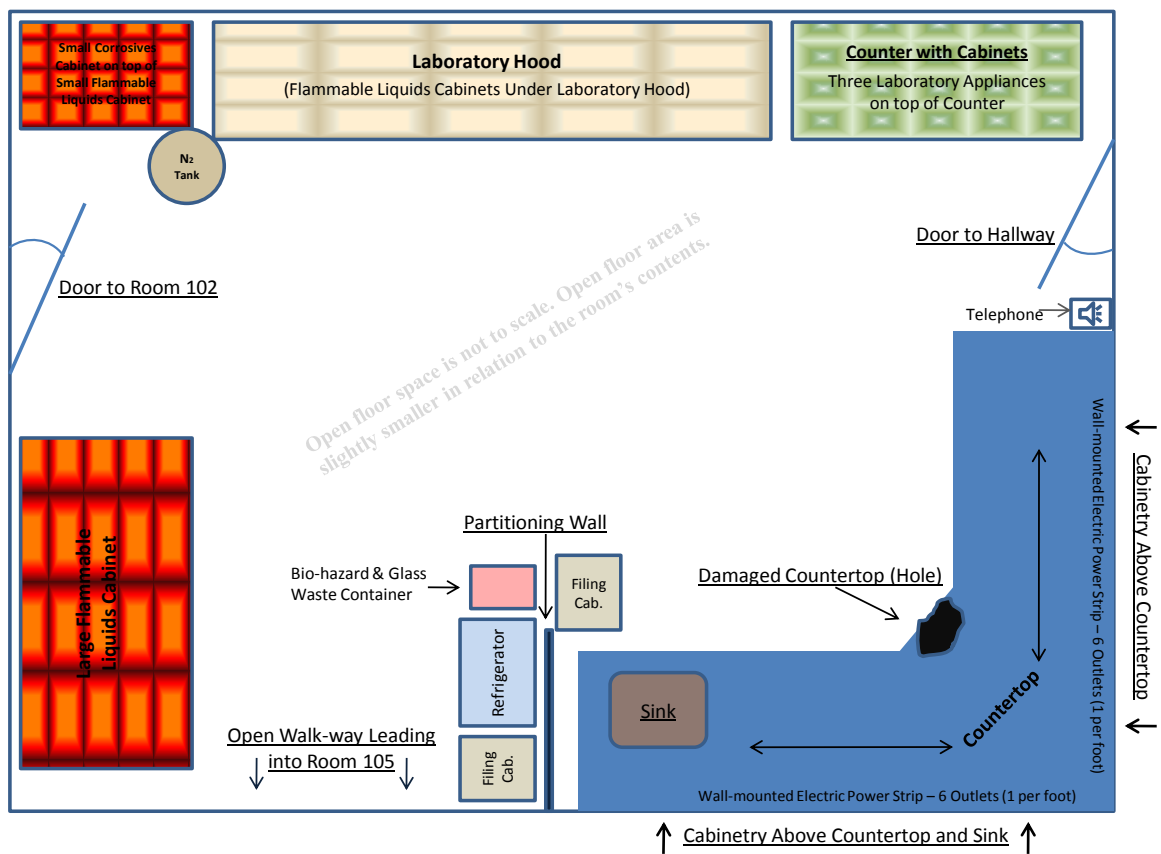
Floor Plan for E3081 Room 103 (approximate dimension = 20' x 30')

They were unlocked, entered by firefighting crews, opened easily, and appeared to be closed during the initial event. There was some indication that the hallway egress door from Lab room 103 may have attempted to be opened after the event by the victim. This conclusion was drawn due to blood staining and smearing on the door which appeared to be consistent with an attempt being made to open the door or at least an attempt to locate the door. After a general and systematic review of visual indicators, flame spread patterns, and damage location and intensity, a determination was made that the initial event occurred on a countertop located in Lab room 103. The basic layout for Lab room 103 is included below.

There was visual discoloration of the ceiling area as well as fire damage to an area of the lab countertop, the wall and cabinet above the sink area, and material that was stored adjacent to the lab countertop. In regard to the victim's blast-like injuries, a location of that blast was determined. It was on the lab countertop in the center outer edge where the counter is pieced together as a 90% unit. There was an operation ongoing in the lab fume hood, but there was no evidence or reason to believe there was any connection with that operation and the event.

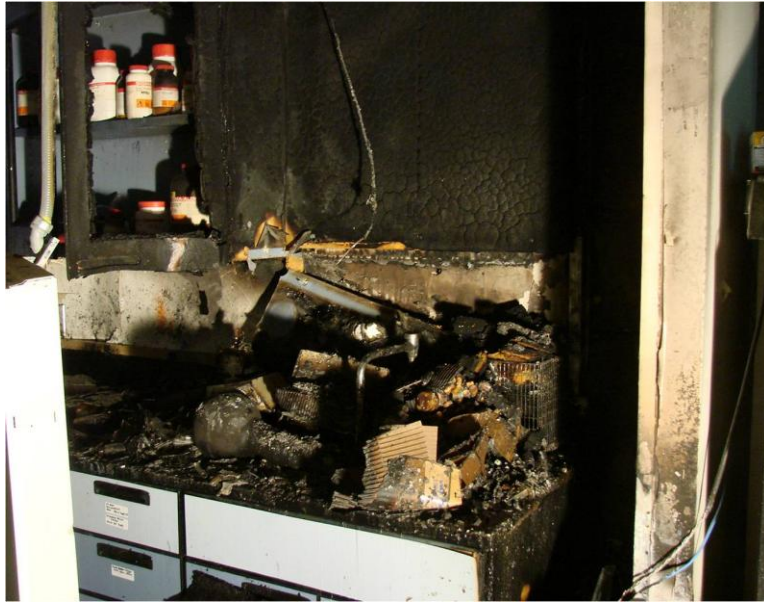
One area of investigative interest was a string of countertop electrical receptacles that showed some evidence of arching at the last receptacle in line. The receptacle did have a lab device plugged into it. The breaker supplying power to it was tripped, and it was located adjacent to the area of most severe fire damage. The power strip was disassembled and photographs were provided to an ATF electrical engineer at the suggestion of State Fire Investigator Selvage. After reviewing the photographs and further visual inspections, it was determined that the arching was a result of flame contact with the wiring and housing, and the circuit breaker tripped due to the short. There was likely power on to the device plugged in at the time; however, it is believed that the damage to that area resulted from the fire and was not related to the cause of the fire nor did it have anything to do with the initial explosion. Fire and smoke damage for the most part was contained to the area of origin with smoke spread occurring through the interstitial space above the lab and out into the hallway continuing to spread throughout the structure. The only activation of the fire alarm system was from a manual pull station in the lobby which was activated by another occupant of the facility. There was no fire suppression located in the facility or in Lab room 103. The fire and smoke damage was estimated at \$40,000.
